INFRARED INSPECTION OF ROOF SYSTEMS

SUBMITTED TO:
Your Public Schools

INSPECTION PERFORMED:
June 15, 2004

Customer: Your Elementary School,
Your Public Schools

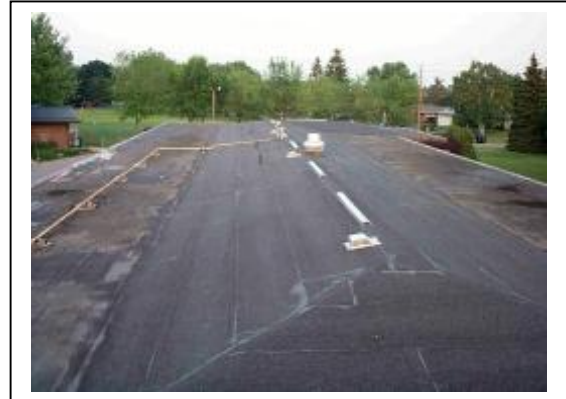
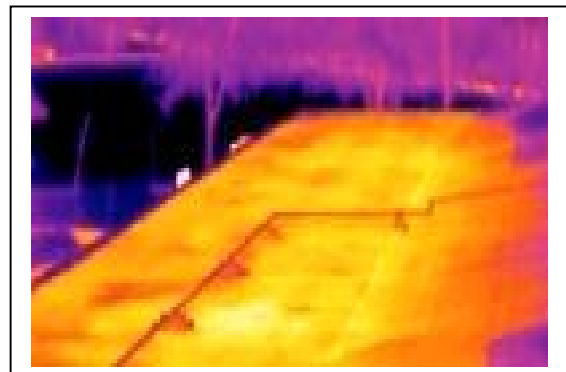
Location: East Wing – North Edge

Problem: Moisture infiltration (yellow/orange area in IR image. Area #1 identified at time of inspection with spray paint. Total wet area = 25' X 160'. Moisture verified with Delmhorst moisture meter. Core cut taken by roofing contractor – 1" fiber insulation board (wet) over previously installed roof membrane.

PRIORITY: IMMEDIATE ACTION

Repair Comments: This area should be reinspected after repair.
